BROOKDALE SENIOR LIVING INC. et al.,

Case No. 4:17-CV-03962-HSG (LB)

**DECLARATION OF DOUGLAS J.
ANDERSON IN SUPPORT OF
DEFENDANT'S RESPONSE IN
OPPOSITION TO PLAINTIFFS' MOTION
FOR CLASS CERTIFICATION**

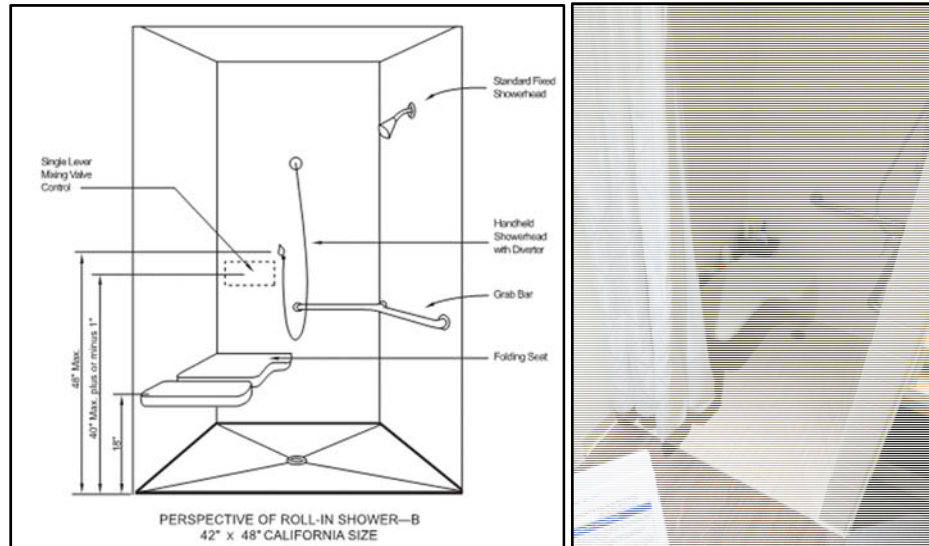
13. For example, until 2007 the California Building Code (“CBC”) allowed a 42” by 48” configuration for accessible showers, as shown in the photo and diagram immediately below this paragraph. The Communities involved in the present case were built between 1961 and 2007. However, the Plaintiffs’ experts used the 2016 and 2019 versions of the CBC to evaluate all of the Communities, regardless of construction or alteration date, and both of those versions of the CBC require different shower configurations. Without knowing when the shower was built or last altered, it

is not possible to know which shower configuration was required at the time of construction or alteration. The Plaintiffs' experts' practice of assuming all elements of all facilities regardless of their construction or alteration date must comply with the most current accessibility codes and standards is incorrect.

Diagram of 42" by 48" shower from the CBC and photo from an existing condition from a Community.

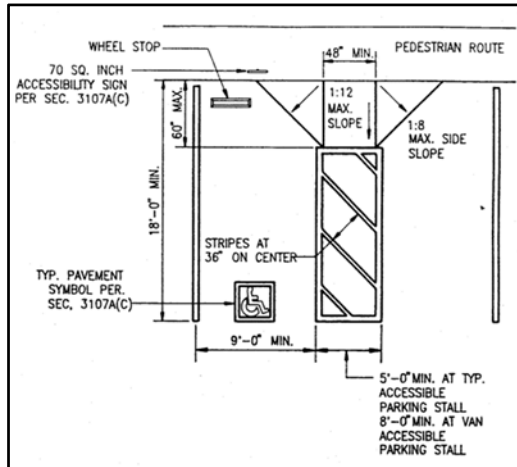
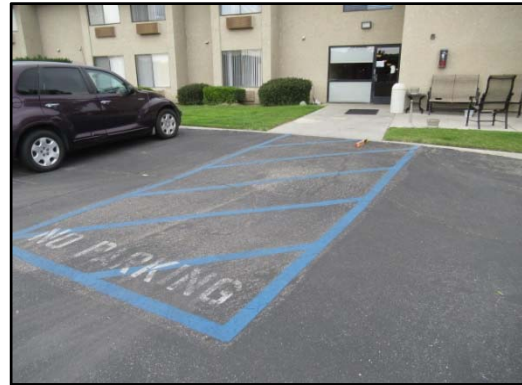
14. As another example, built-up curb ramps were allowed in access aisles of accessible parking spaces in the CBC until 1994. If a parking lot has those built up curb ramps, and has not been altered since 1994, then there is no violation of the CBC. However, this is a condition that the Plaintiffs' experts called out as a violation at multiple Communities, without regard to the date of construction or alteration of the parking lot. To illustrate, below is a diagram of a built-up curb ramp from the 1994 CBC and photo of an existing built-up curb ramp condition from a Community from Plaintiffs' experts' report, but for which they did not note the date of construction or alteration.

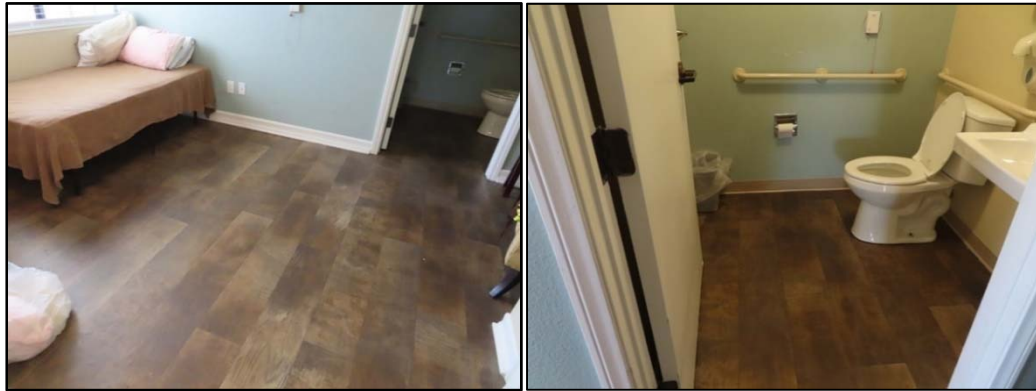
Corona Community residential unit.

21 43. I also found that where Plaintiffs' experts proposed a potential barrier removal action, it
22 may not have taken into account the realities of the condition or space, let alone whether removal of the
23 barrier is readily achievable. For example, Plaintiffs' expert indicated that he found the bathroom
24 shown in the residential unit in the photos below for the Corona Community to lack sufficient turning
25 space. His proposed barrier removal of enlarging and reconfiguring the bathroom in one of the
26 residential units would require reducing the living space and reframing of walls (and assumes the wall
27 proposed to be removed is not load-bearing or containing immovable infrastructure).

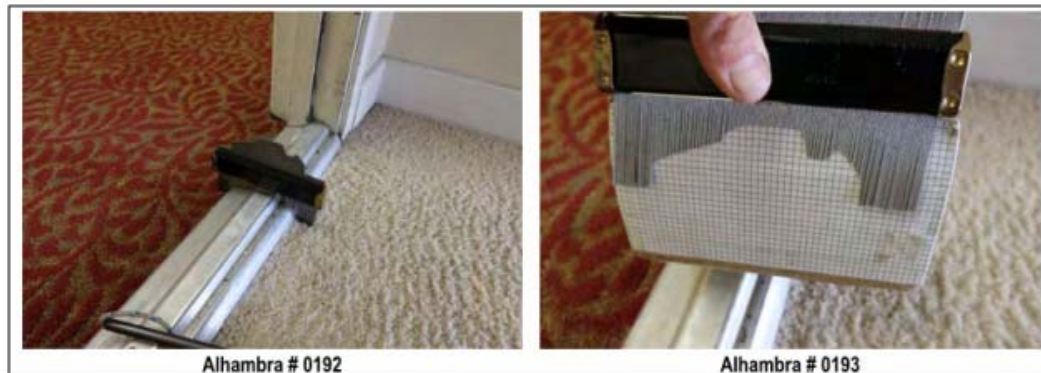
51. It also appeared that Plaintiffs’ experts used nontraditional survey equipment to find extremely small deviations. For example, a precision tool intended for custom millwork projects such as cutting compound molding angles was used to measure door thresholds. Use of such precision may cause them to call out minute differences that are within construction tolerances and not barriers, and to inflate the number relevant issues beyond those that could properly be considered barriers on the site.

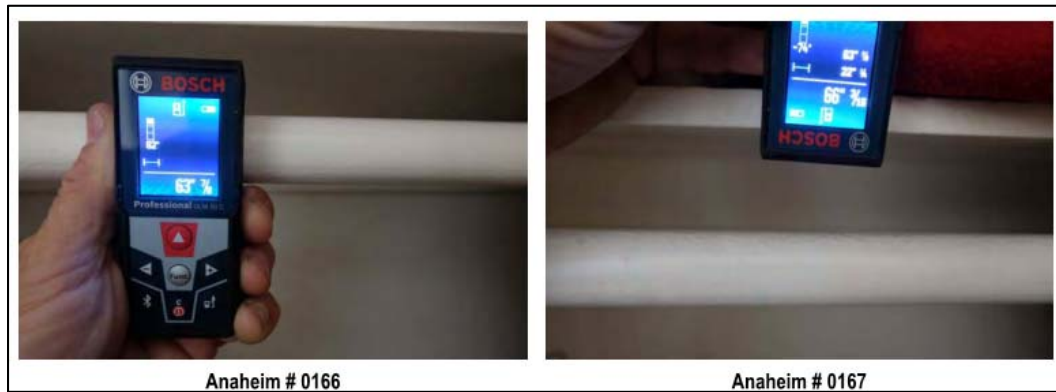
52. As another example, use of an electronic tape measure for determining height of closet rods and coat hooks, as seen in the photos below, or the height of trees or deployed table umbrellas, while suspending the tool over the floor without support can yield inaccurate readings.

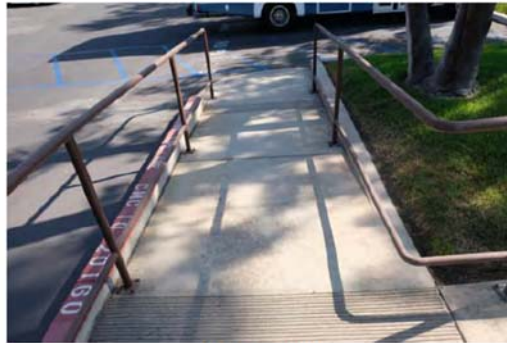
Corona # 0467

54. Specifically, some of the findings in Plaintiffs' experts' reports do not provide photographs showing the measurement of the alleged barrier so I was unable to verify the issue or see where the measurement was taken. For example, as shown in the excerpt from Plaintiffs' Corona report copied immediately below, the report indicates a bottom landing slope was 3.9%, but no photo of the condition was provided nor description of the location of where the 3.9% measurement was taken. My team's field measurements of the bottom landing in the area where we assumed Plaintiffs' experts were referring did not find a 3.9% measurement. Our readings ranged from 0.4% to 2.4%, which are all under or within construction tolerance for ADA slope measurement requirements. The general acceptable construction tolerance standards for the building industry are documented in a book titled "Handbook of Construction Tolerances" Second Edition by David Kent Ballast. This breaks down several design and construction elements and we believe provides a good overall reference.

7	Ramp – Landing Slope	Is the slope of top, bottom and intermediate landings no more than 1:48? (≈ 2.1%)	11B- 405.7.1	11B- 405.7.1	4.3.7	405.7.1	Barrier: The slope of the bottom landing of the lower ramp is 3.9%. Barrier Removal: Remove and replace landing. Photos: 461 thru 477
---	-------------------------	---	-----------------	-----------------	-------	---------	--

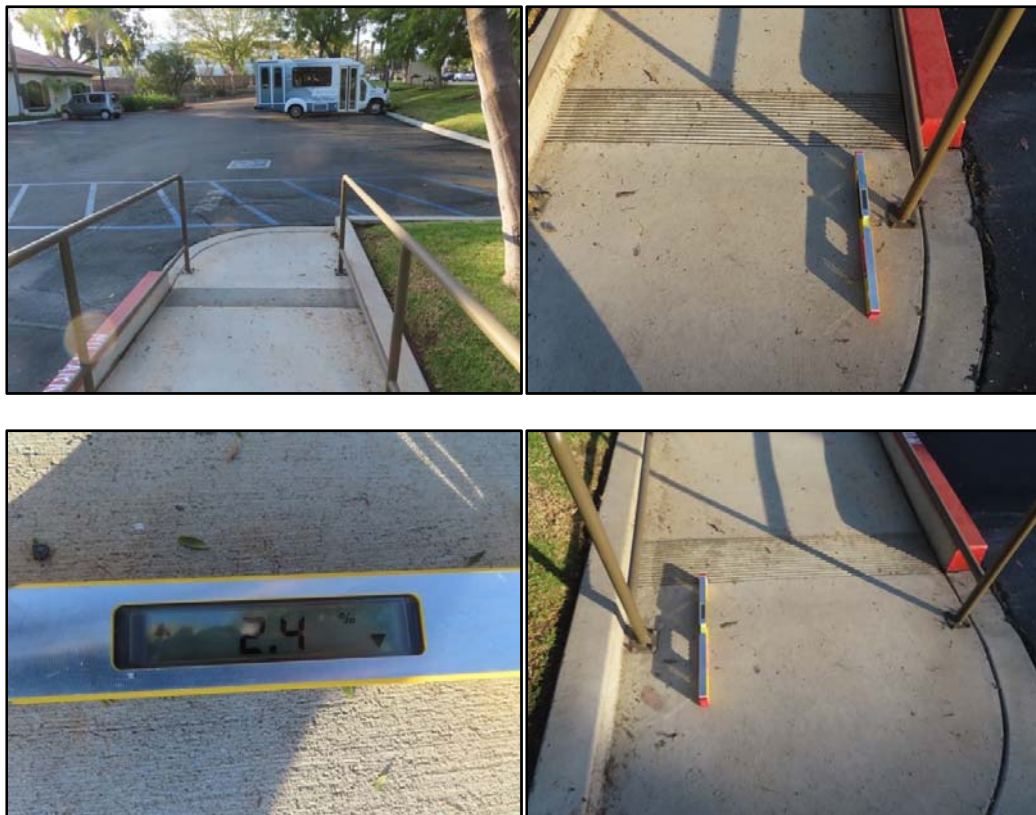
Photos from LCM Review of Corona Report Show bottom landing slope ranges from 0.4% to 2.4%.

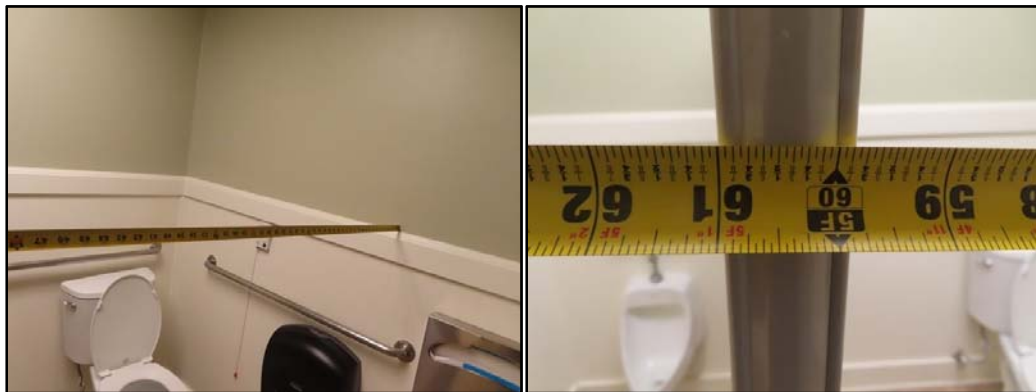
55. We found many incorrect measurements in our review of Plaintiffs' experts' reports such as the toilet compartment at North Euclid pictured below. The Plaintiffs' report listed this as an alleged violation with a width of 57.375". No photo of their measurement was provided, but our measurement showed 59.875"—well within construction tolerance for the ADA 60" ADA requirement for this element.

Photos from LCM's field review of the North Euclid report.

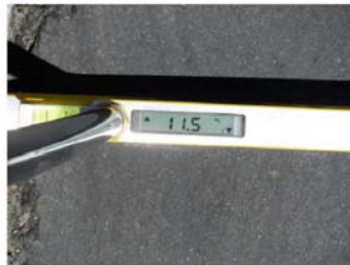
DSCF4431

56. Some of the Plaintiffs' findings were misleading about the severity of conditions at different Communities. One example of an overstated issue was at the Scotts Valley Community parking, where the Plaintiffs' report indicated that the slope of the parking space was measured up to 11.5%. This extreme slope measurement was taken in the gutter pan in front of the parking space—

159	Accessible Parking - Slope	Is the slope of the accessible parking spaces and access aisle serving them not more than 1:48 (2.1%) in any direction?	11B-502.4	11B-502.4	4.6.3	502.4	Photos: See aerial photo Barrier: The slope of the accessible parking spaces and access aisle exceeds 1:48, measured up to 11.5%. Barrier Removal: Overlay or replace the paving at the accessible parking spaces and access aisle as required to provide a slope not more than 1:48. I recommend accessible spaces be constructed in concrete. Photos: 4415 thru 4422
-----	----------------------------	---	-----------	-----------	-------	-------	---

Scotts Valley gutter pan slope

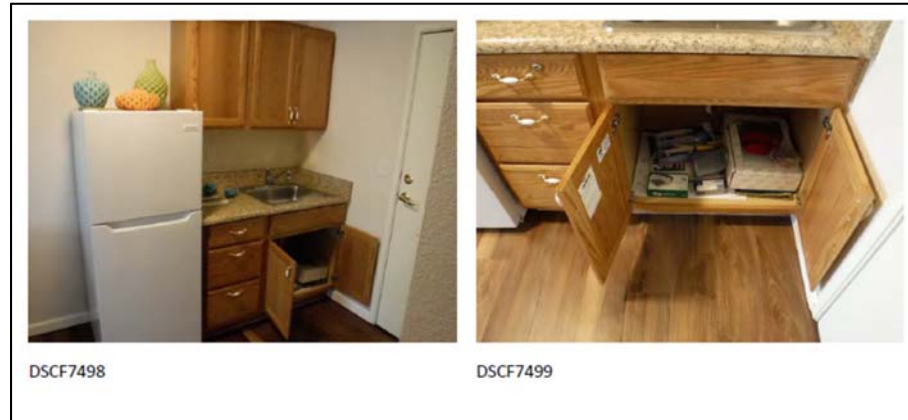
1 to unit 311 “except where noted”. However, I found that unit 120 was a unit with accessible features
 2 whereas unit 311 was a standard unit with no accessibility features—yet the Plaintiffs’ experts noted no
 3 differences between the units on their report, and the two units were in no way similar. This is a
 4 significant oversight. The differences between those two units are clearly seen in the photos below.

5 Unit 311 – Kitchenette photos from Plaintiffs’ expert:

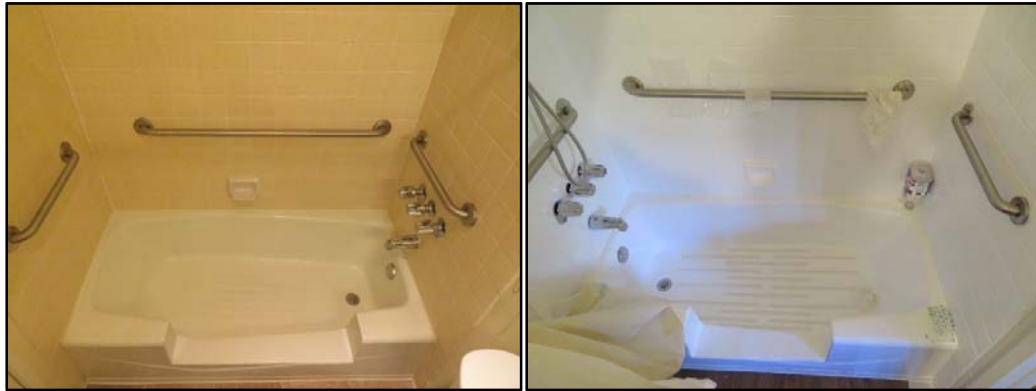
Chatsworth Cut Wall Tubs:

59. Another issue plaintiffs raised that was misleading relates to the application of roll-in shower standards to modified bathtubs. A modification we found that a Community may have made at a resident’s request is lowering or removing a sidewall of a bathtub to make it easier for a user to transfer their feet and legs into the basin of the tub when using a tub seat or chair. Plaintiffs’ experts always erroneously identified these tub modifications as roll-in showers with inaccessible layouts.
